Expedient site construction provided housing for Mississippi residents displaced by Katrina

Geosynthetic materials helped in offering a solution for the construction of temporary roads and group housing sites atop wet and soft soil conditions.

By Lloyd W. Young Jr. and Robert E. Jordan

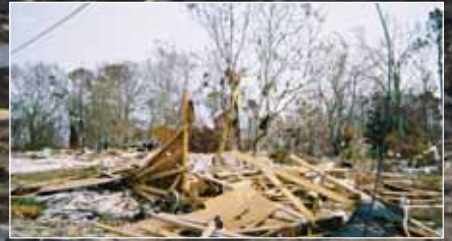
Photos 2 & 3 | Common post-Katrina sites: Demolished housing and tangled debris.

The storm’s destruction within several miles of the Gulf shoreline in many cases left almost nothing intact. It demolished houses, schools, and other buildings, often leaving little more than a cement slab or a tangled pile of debris (**Photos 2 and 3**).

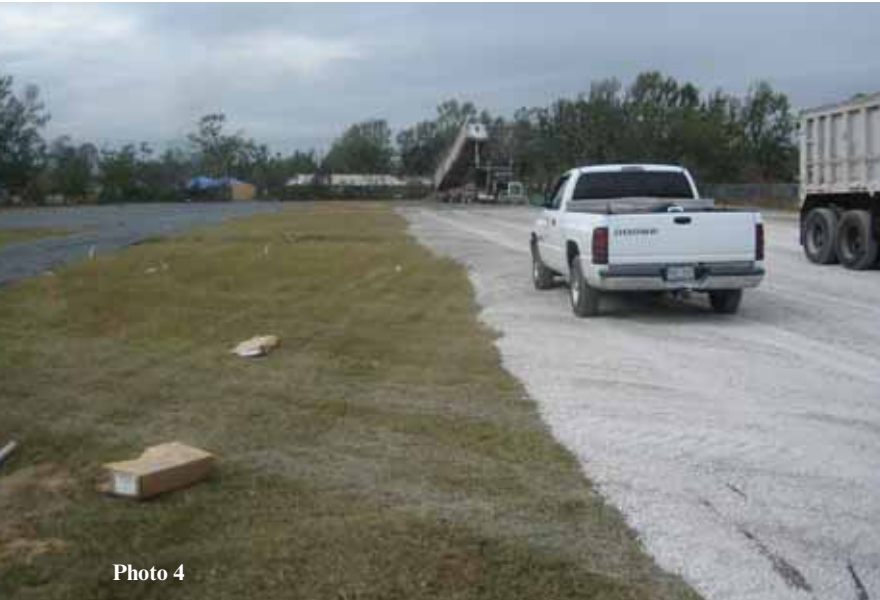
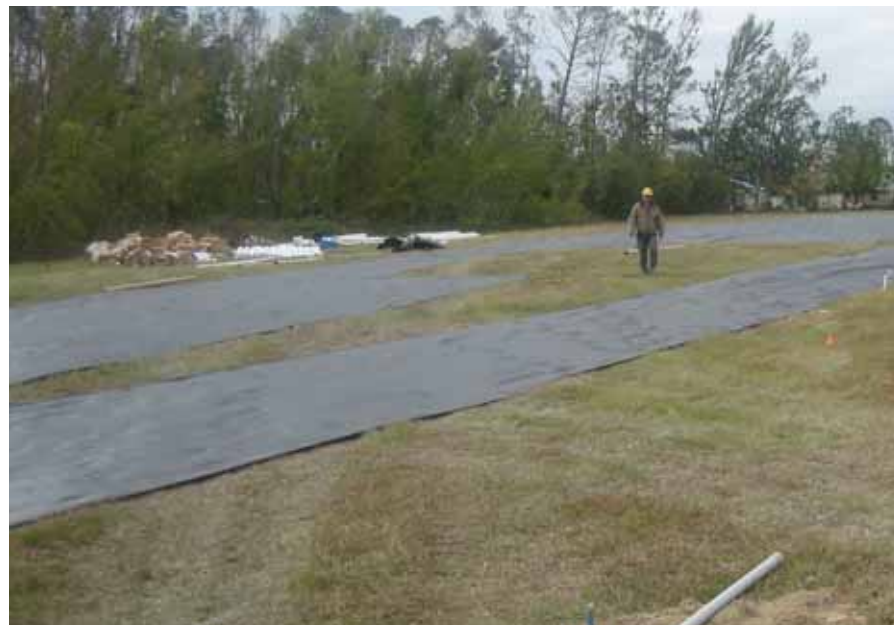
Photo 4

To minimize the loss of aggregate into the subgrade soils and to provide some degree of reinforcement, MDOT Type 5 nonwoven geotextile was specified for placement under the aggregate. **Photos 4 and 5** show the geotextile being unrolled for a group site roadway over the grass and topsoil, with the aggregate placed and compacted.

Photos 4 & 5 | Part of the solution was an application of up to 4 layers of geotextiles and aggregate, with just one layer applied to the stronger sites and perhaps all 4 layers needed for the softer sites.
